# Performance Evaluation of Machine Tap for tapping Al6061-T6 Aluminium Alloy

**Abstract**—The present study deals with tapping of Al6061-T6 alloy specimen in dry condition. The study aims at determining the progressive wear of M8 HSS machine tap due to machining. The characterisation of the specimen was done by conducting hardness and tensile test. The tapping tool experiments were conducted on a radial drilling machine using an automatic tapping attachment. Kistler drilling tool dynamometer was used to record the thrust and torque during tapping. The progressive wear of the tool was evaluated by weight loss method. From the experimental study it was observed that wear in the tap was considerably less due to soft nature of the work piece material Al6061 T6 alloy. During tapping operation, the thrust force and torque found to increase with tool wear due to progressive wear of machine tap.

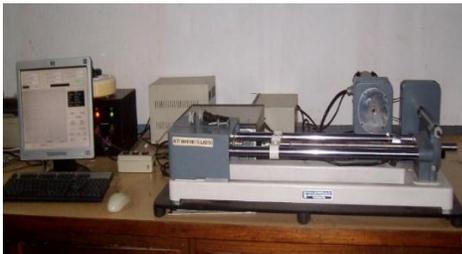
Fig.1: Electronic Tensometer TMER3

The tensile test of the Al 6061 alloy was tested using Electronic Tensometer TMER3 (Khudal Instruments, Pune make), shown in the figure 1. The size of the test specimen is shown in figure 2. The average of tensile test values of three samples were determined to estimate the representative tensile strength of the material. The tensile strength of the Al6061-T6 specimen as obtained, was found to be 791.7 N/mm<sup>2</sup>.

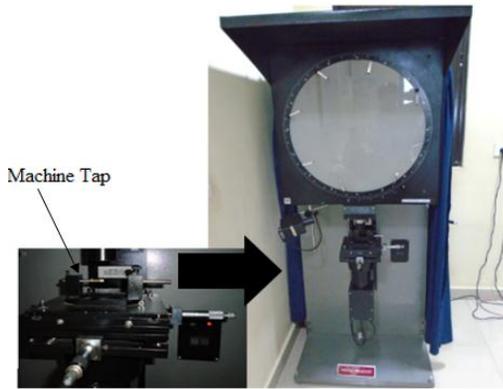
Fig.8. Machine Tap positioned in the Profile Projector for Wear measurement

**I. By Using Profile Projector:** The wear pattern of the machine tap was measured using a profile projector (METZER, India make) as shown in fig.8. The profile measurement was done at magnification of 20X. The profile of the teeth in the chamfer portion of the tap was traced from the display in the profile projector, before the start of tapping as shown in fig. 9. Subsequently the same procedure is repeated after tapping at every interval of 50 holes, up to 450 holes. During this, the reference axis of the tap is made to coincide with cross wire in the display of profile projector, to avoid positioning error. All the cutting edges in the chamfer portion including the first full depth thread at the end of chamfer section undergo progressive wear with increase in number of holes tapped. In addition to this, the first full depth thread is responsible for cutting the thread to the desired size as it is the last thread in the cutting section of machine tap. Therefore, progressive wear of other cutting edges in the chamfer portion causes additional burden or load on the full depth thread to perform the task. Hence the cutting edges of the first full depth thread is taken as reference for estimating the progressive flank wear of machine tap.
